# Manhole Inspection Summary

Manhole # S03CC2025MH

**Location** Address: **6100 WESTERN RUN DR**

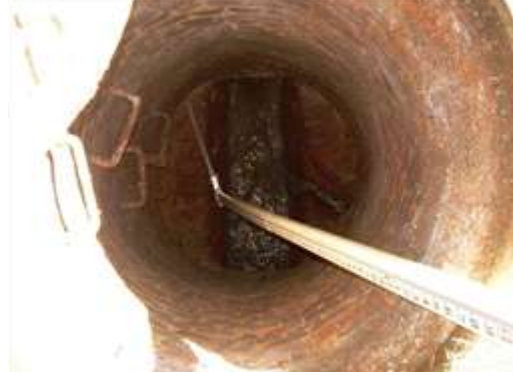
Top View

☒ **Leaks**

Infiltration: ☐ None ☒ **Joint** ☐ Cracks ☐ Mortar ☐ Roots ☐ Wall

☒ **Corroded**

Frame leaks. Adjustment infiltration.  
Corroded steps.

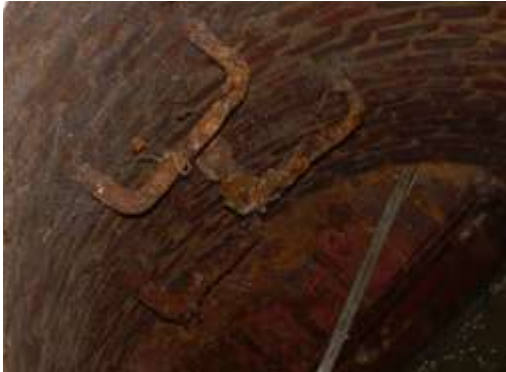
Evidence of surcharge

☒ **Evidence Of Surcharge**

Depth: **4**

Evidence of surcharge.

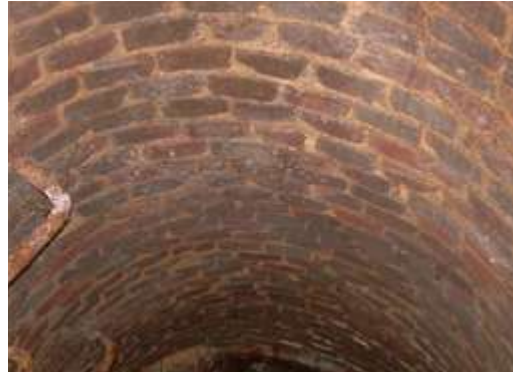
Defect

Condition: ☐ Sound ☐ Cracked ☒ **Root Intrusion** ☐ Loose Brick ☐ Deteriorated

Infiltration: ☐ None ☐ Joint ☐ Cracks ☐ Mortar ☒ **Roots** ☒ **Wall**

Barrel root intrusion and infiltration..

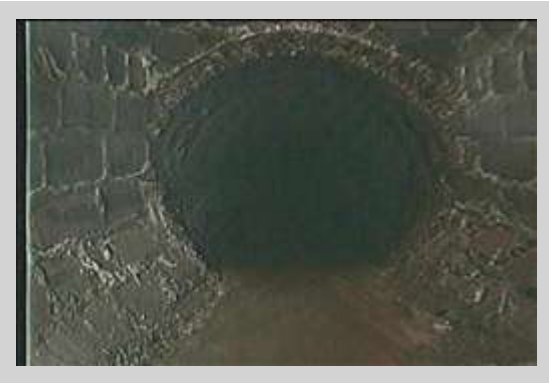
### 21 in. Circular Gravity Sewer Pipe Out @ 12 O'Clock

Infiltration: **Evidence** Pipe Seal Cond: **Unknown**

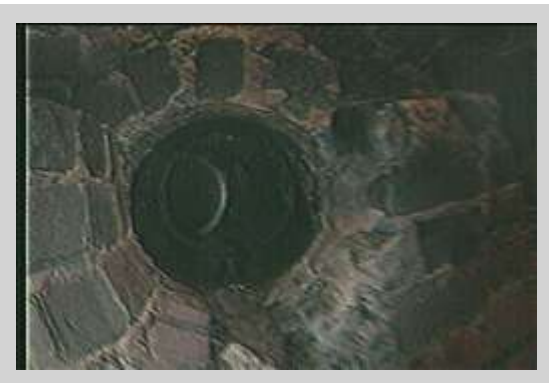
### 8 in. Circular Gravity Sewer Pipe In @ 4 O'Clock

Infiltration: **Evidence** Pipe Seal Cond: **Unknown**

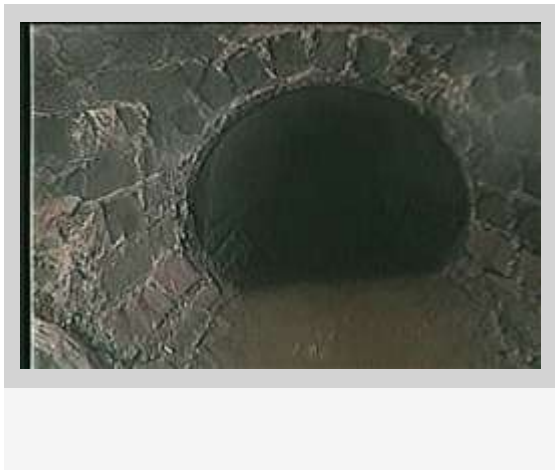
21 in. Circular Gravity Sewer  
Pipe In @ 6 O'Clock

Infiltration: **Evidence** Pipe Seal Cond: **Unknown**
